# Libby Asbestos Site

Libby, Montana

Operable Unit 1 –  
Former Export Plant Site

Revision 1 Draft  
Final Data Summary Report

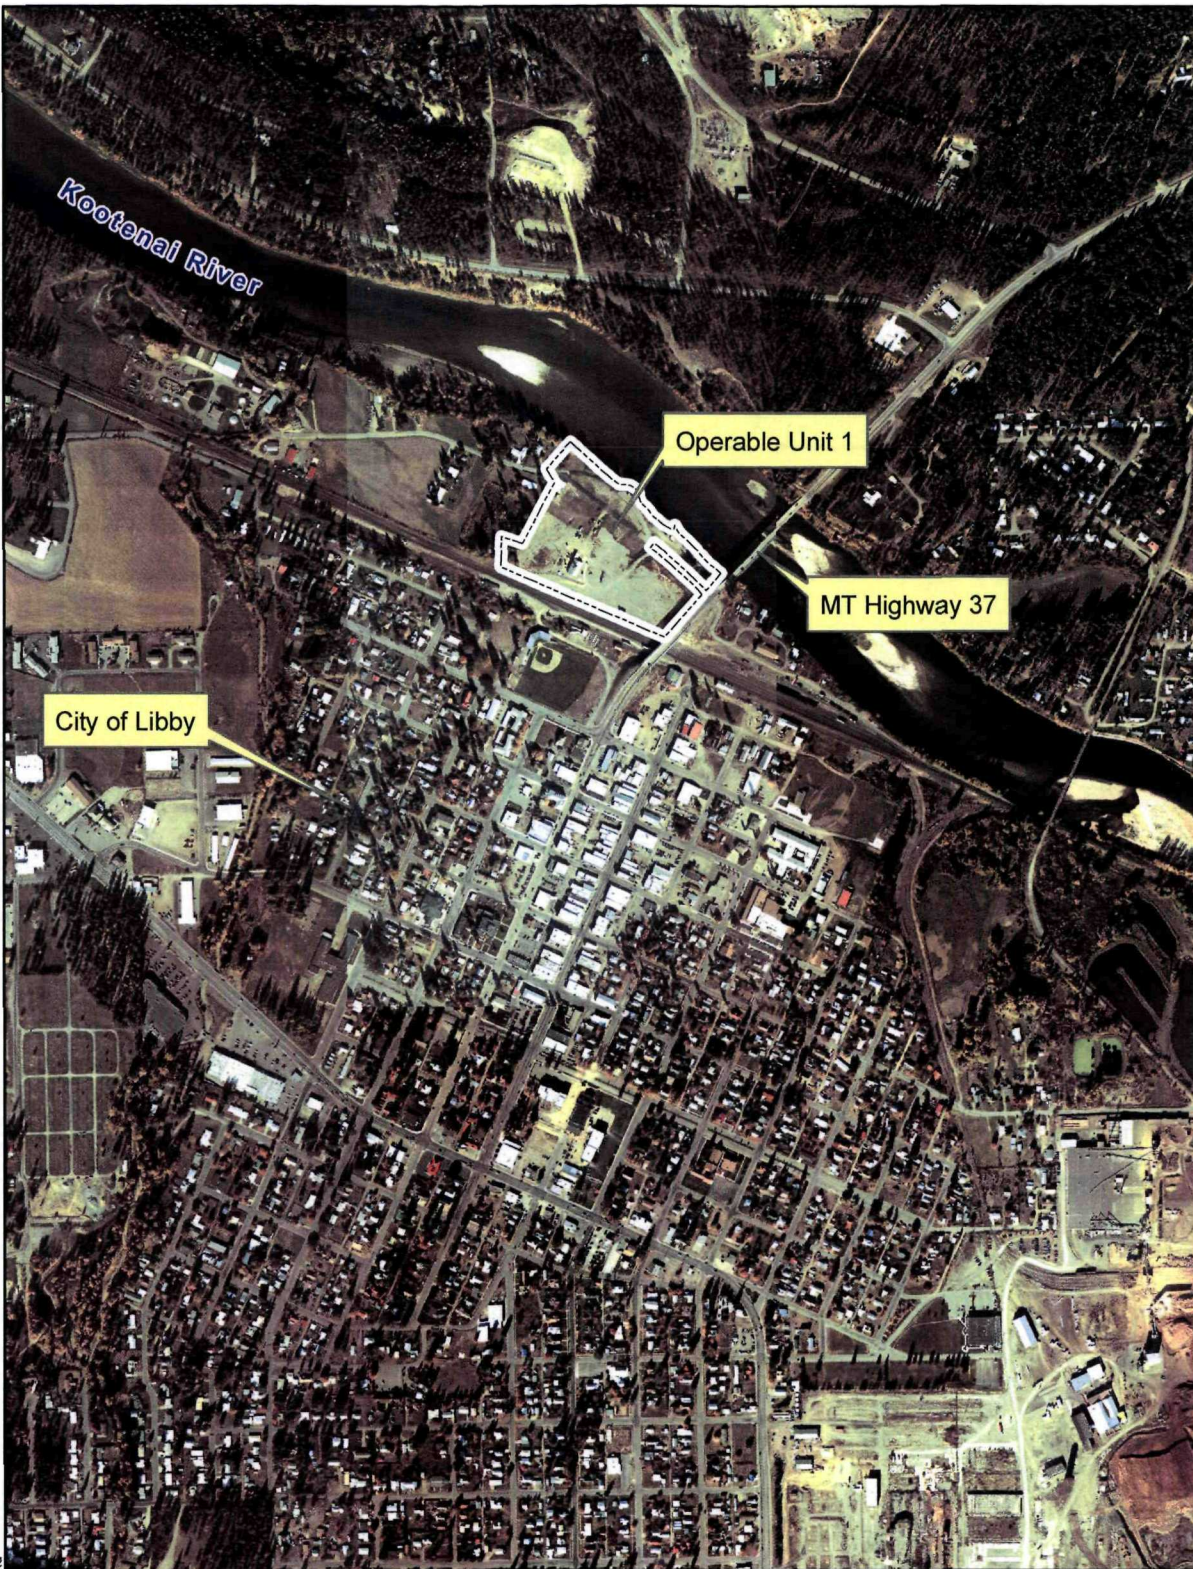
The OU boundaries depicted are based on the definitions found in the Libby Asbestos Conceptual Site Model. Because investigation of the nature and extent of contamination continues, the OU boundaries are subject to change. These OU boundaries are current as of June 2007.
